HILLSMERE SHORES COMMUNITY SHORELINE STUDY BEACH ASSESSMENT AND STABILITY REPORT

Prepared for:
Hillsmere Shores Improvement Association
611 Harbor Drive
Annapolis, Maryland 21403

Prepared by:
Environmental Systems Analysis, Inc.
162 West Street
Annapolis, MD 21401
www.esatoday.com

March 2010

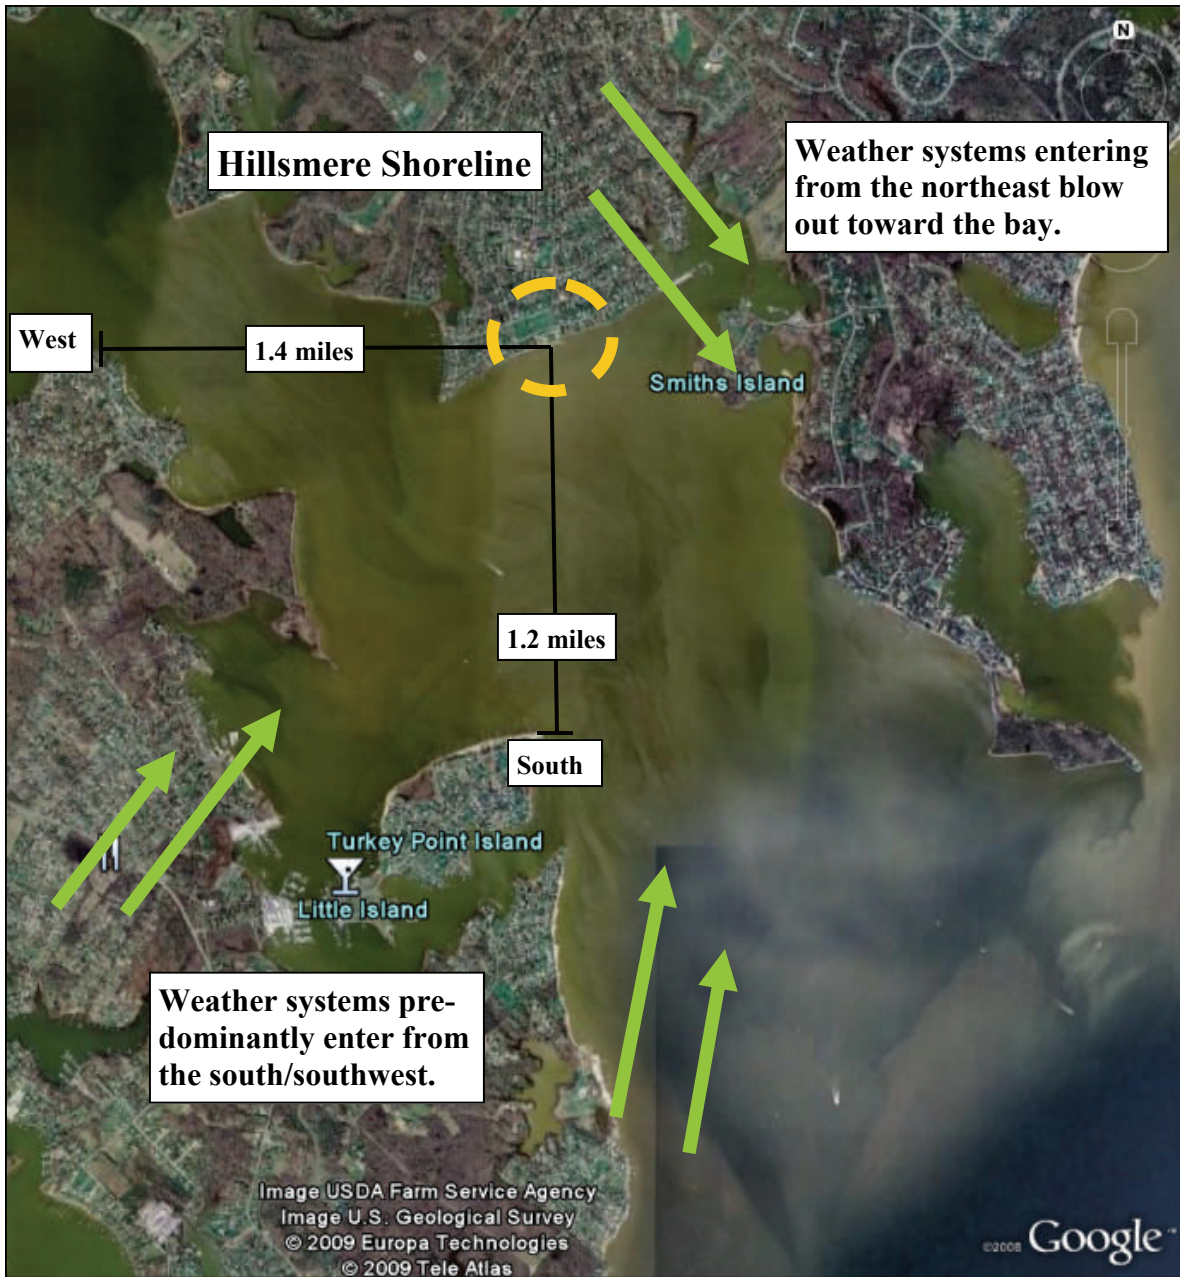
Figure 2. Storms typically enter the state of Maryland from the south/southwest and northeast. Despite the sites long stretches of apparent fetch the area is well protected by features like Turkey Point, shallow shoals, and the southern tip of Hillsmere peninsula. Storms entering from the northeast blow away from the Hillsmere shoreline. The shoreline's northeasterly aspect helps to deflect/dissipate wave energy associated with storms and plays a role in longshore transport.

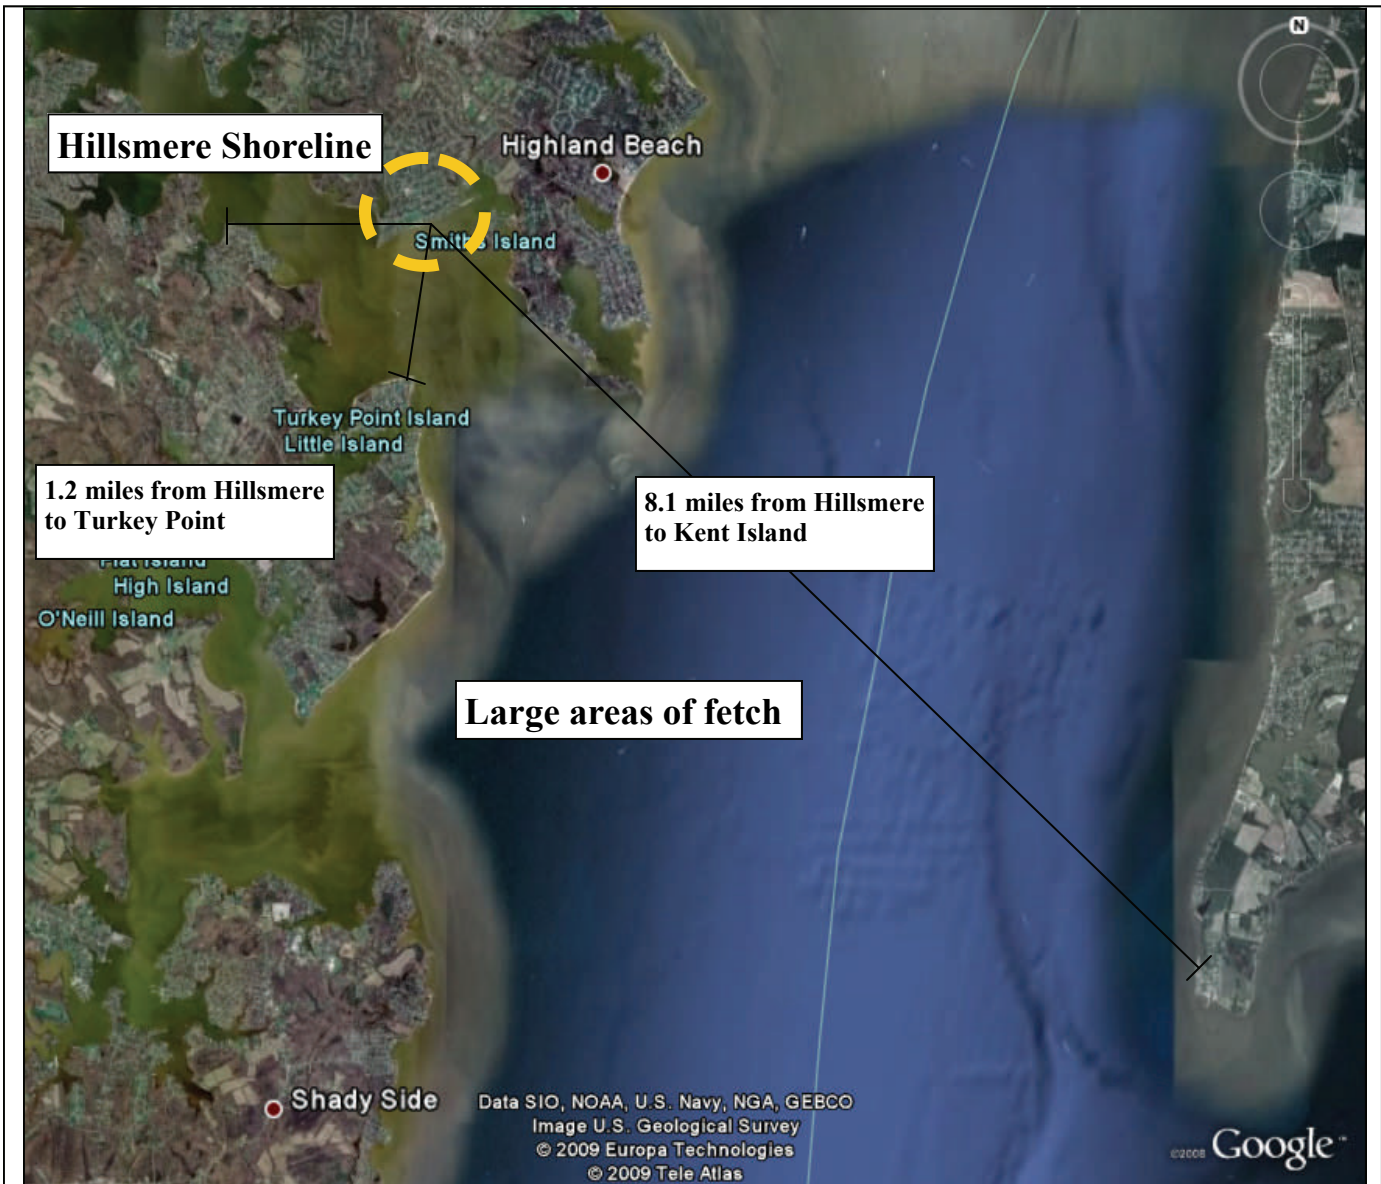
Figure 4. The Hillsmere shoreline initially appears vulnerable during storms due to long stretches of fetch. Storms typically enter the state of Maryland from the south southwest and northeast. The Hillsmere shoreline is actually well protected from storm systems by shallow shoals and protruding land features like Turkey Point.

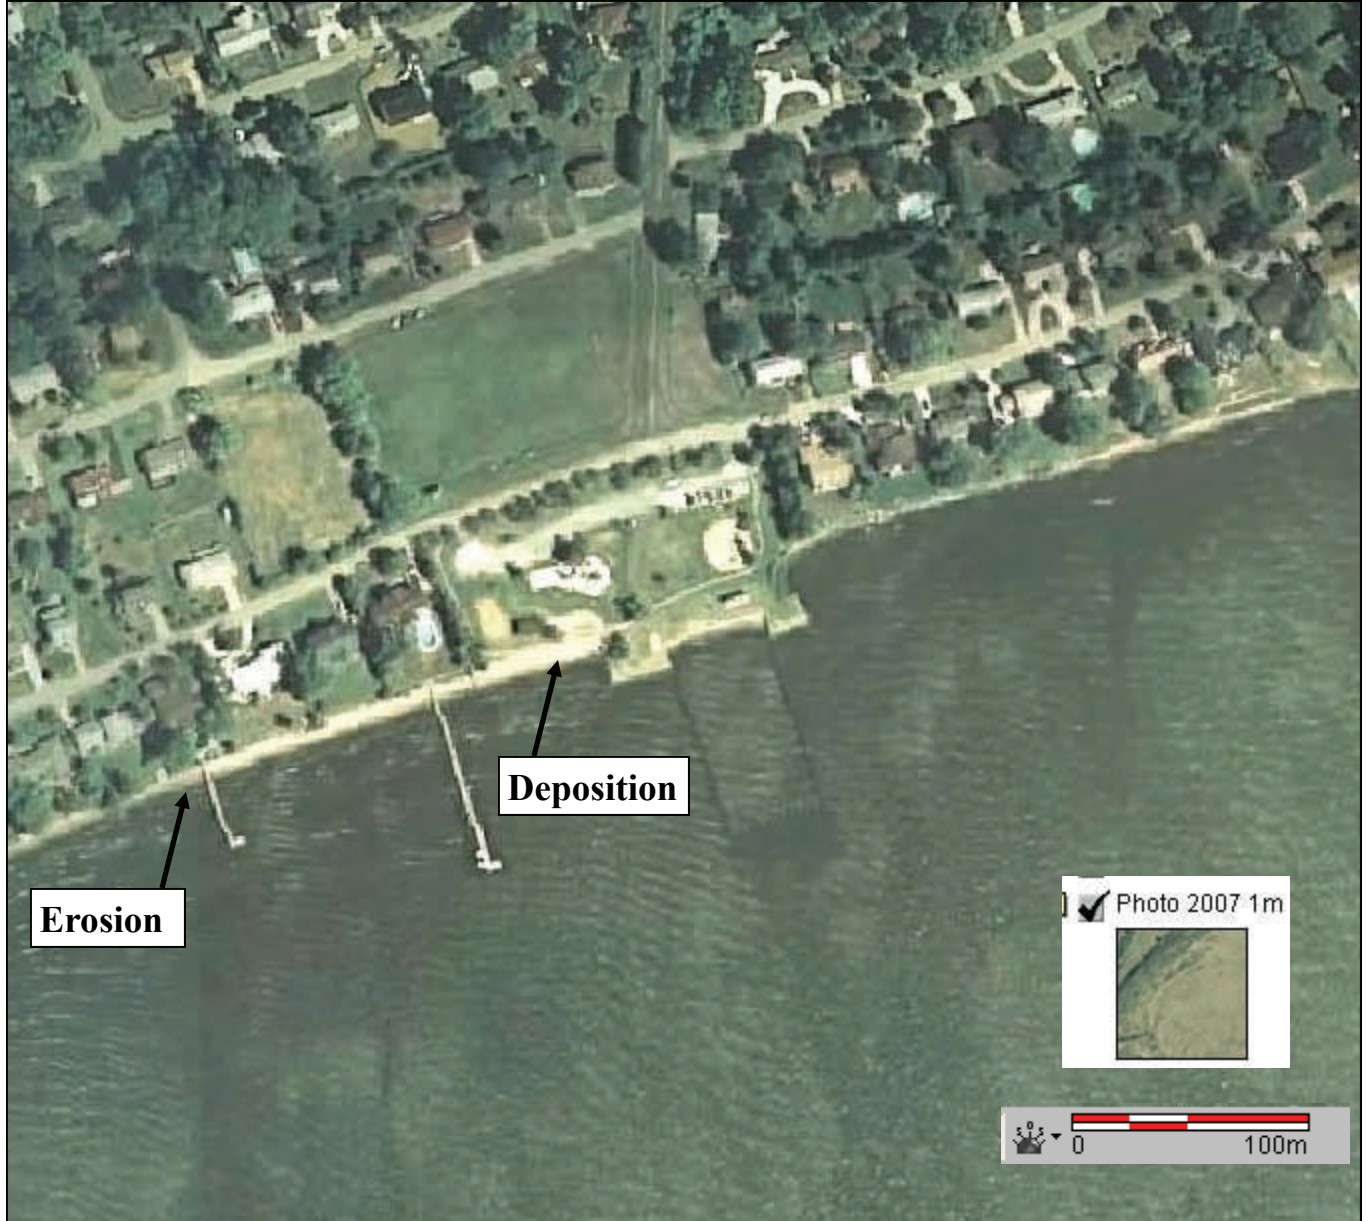
Figure 9. Current erosion and deposition features at Hillsmere Shoreline. Deposition is occurring along the southwest bulkhead. Aerial photo from 2007.

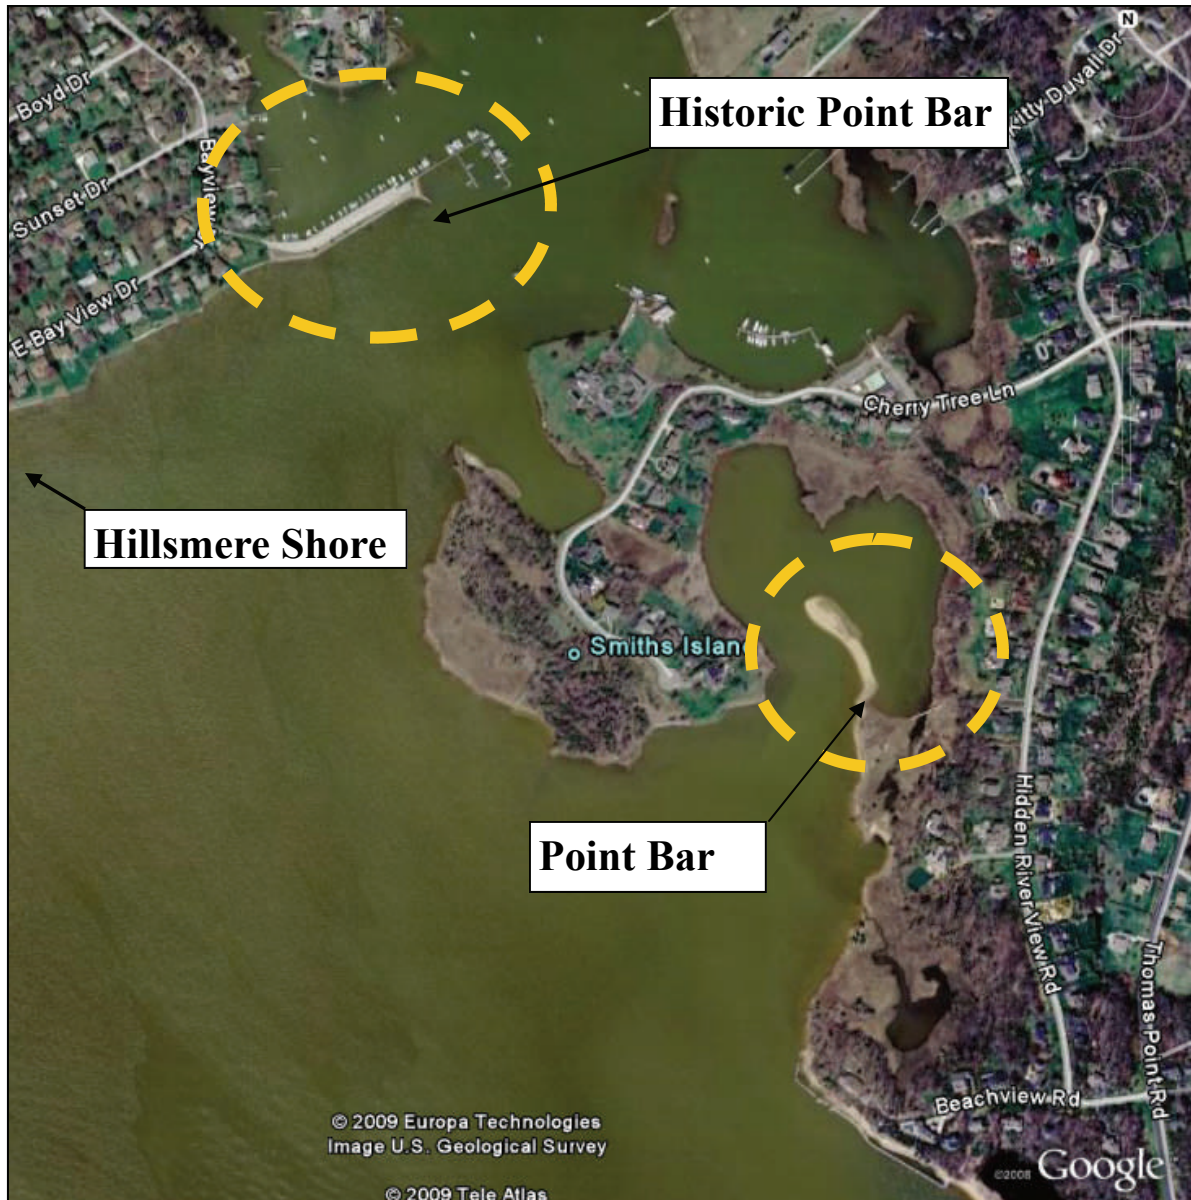
Figure 11. Point bars can result when littoral drift occurs uninhibited by shoreline structures. This point bar is a result of littoral drift accretion in Cherrytree Cove. Historically transport lead to a point bar extending from the shoreline into Duvall Creek. This point bar has since been converted into a marina. The rip-rap bulkheads at Hillsmere inhibit some transport into Duvall Creek.

Historic erosion trends may have been the result of longshore transport before bulkheads were installed at Hillsmere Shoreline. Since the shoreline protection structures have been installed, the shoreline has experienced relatively little erosion (Figure 13). Historic longshore transport may have lead to the formation of a point bar in Duvall Creek which has since been converted into a community marina (Figures 11 and 12).

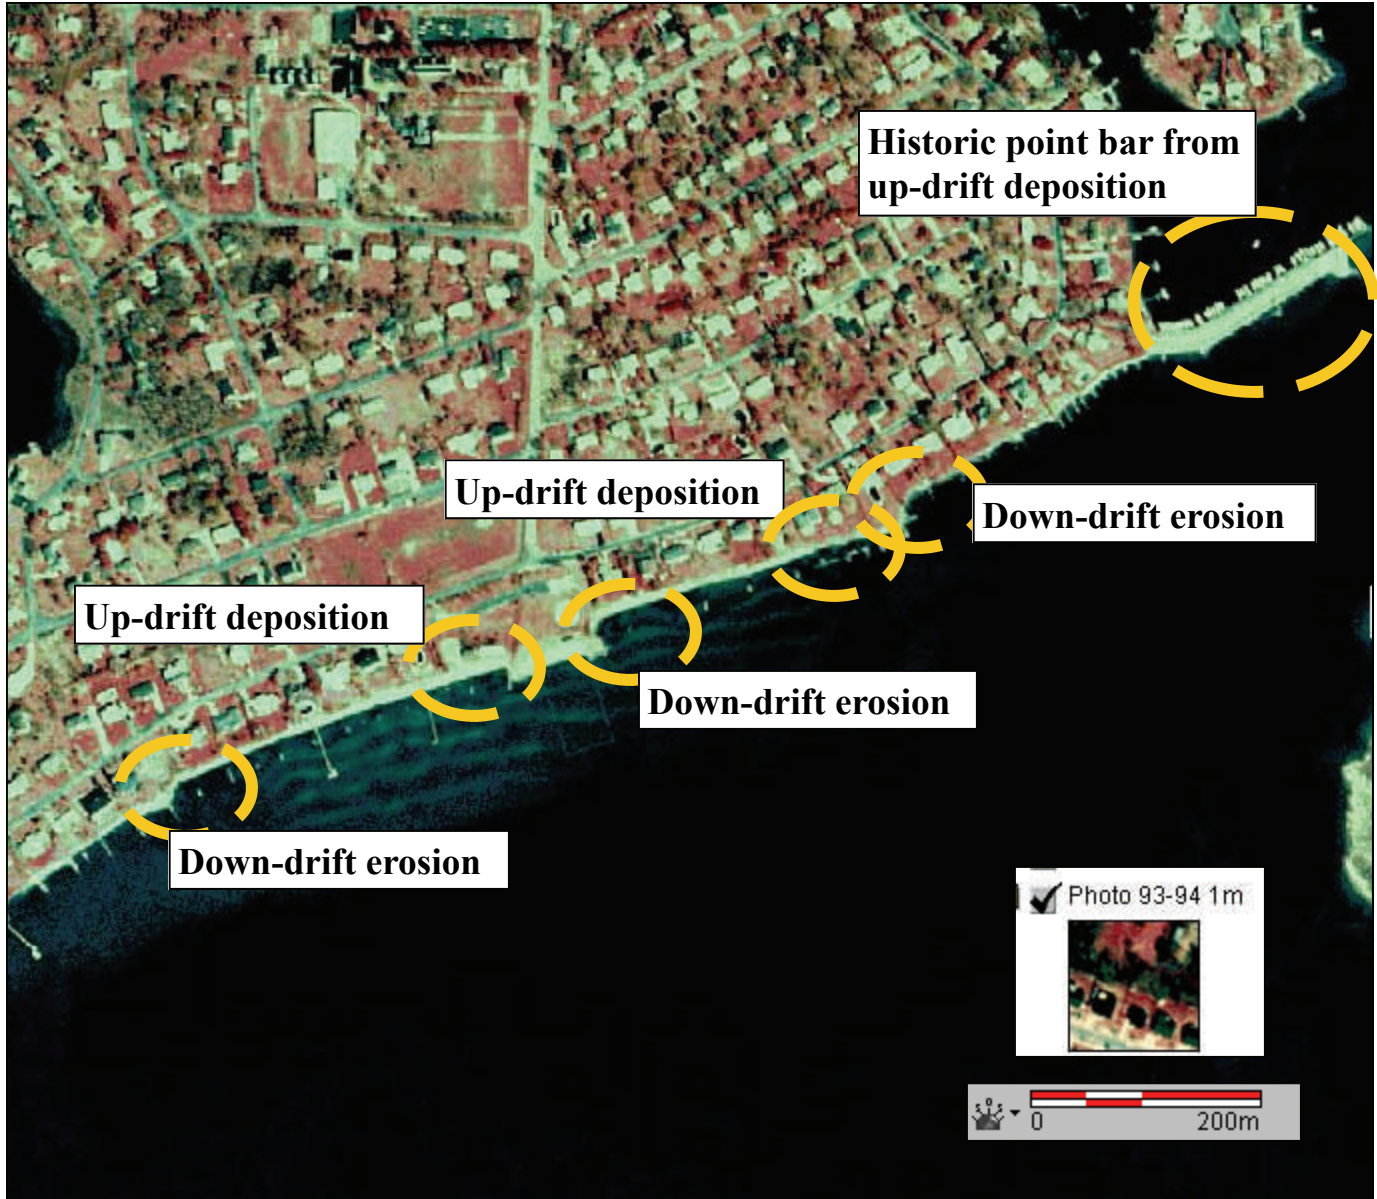
Figure 12. Material is transported along Hillsmere Shoreline into Duvall Creek. Current bulkheads inhibit this transport leading to deposition along the southwest bulkhead. Classic up-drift deposition and down-drift erosion normally associated with structures that interfere with littoral transport seems to be occurring at Hillsmere.

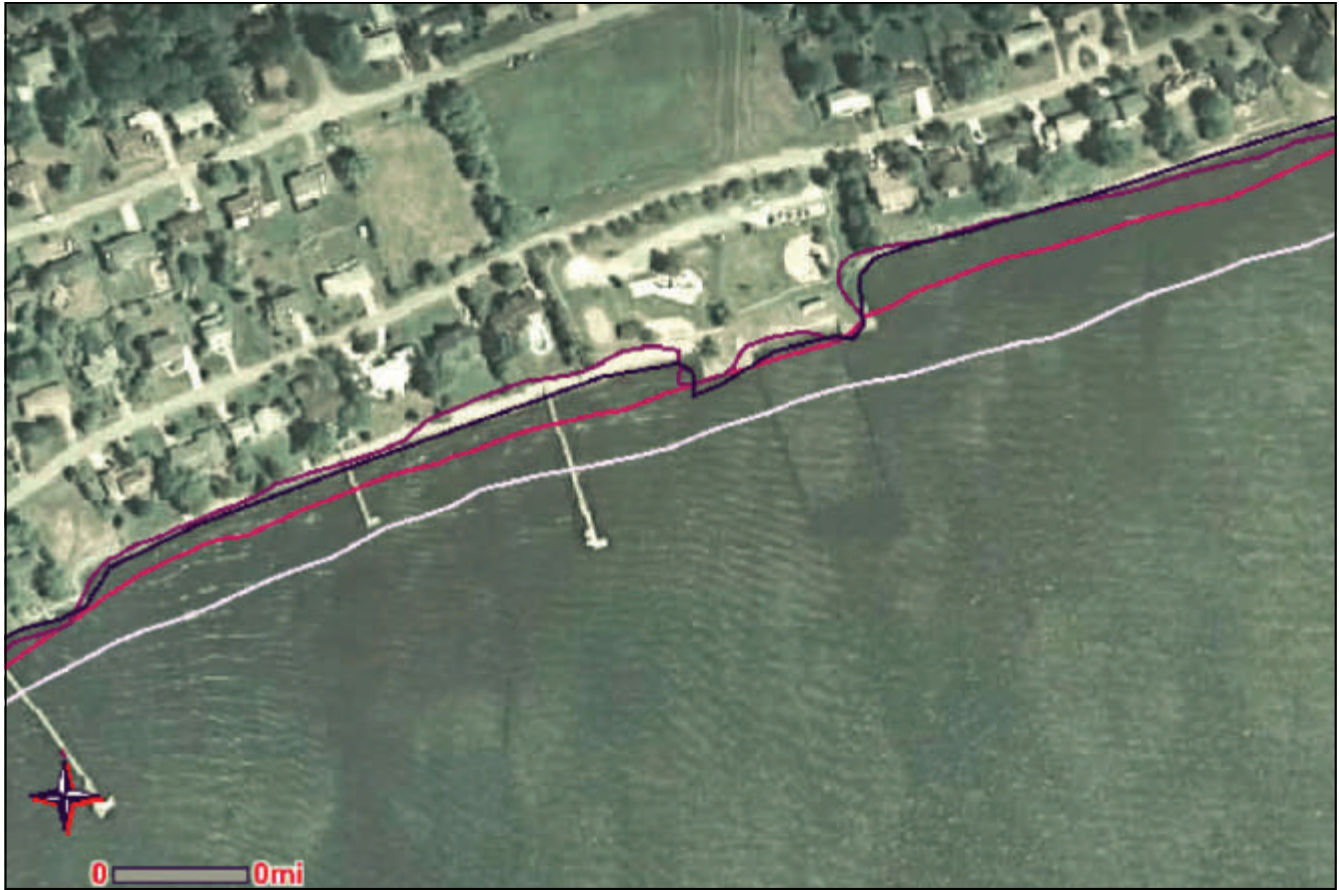
Figure 13. Historic Shoreline. Historic erosion trends may have been the result of longshore transport before bulkheads were installed at Hillsmere Shoreline.

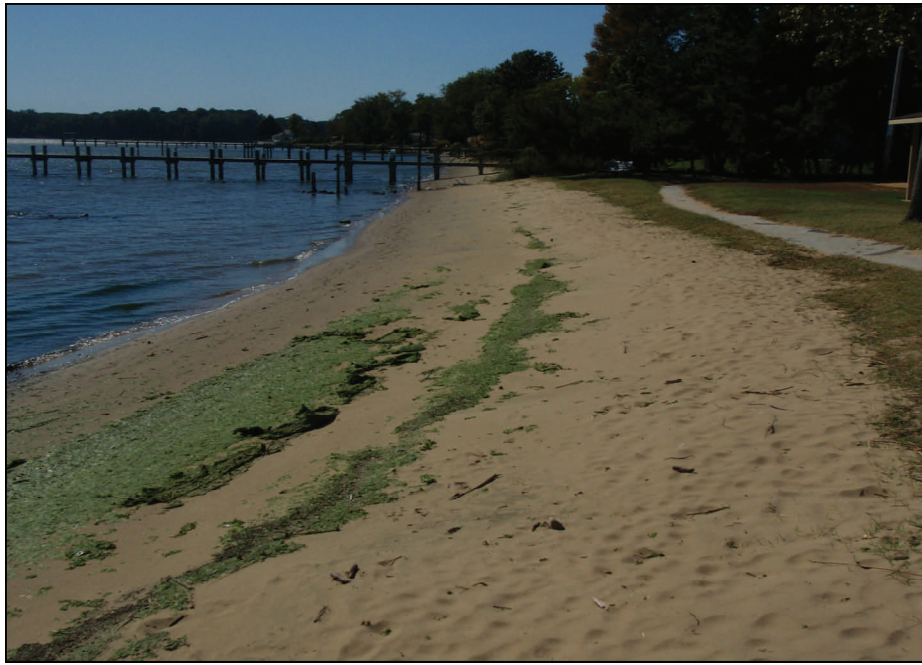
Figure 15. Gradually sloping natural beach area looking southwest.

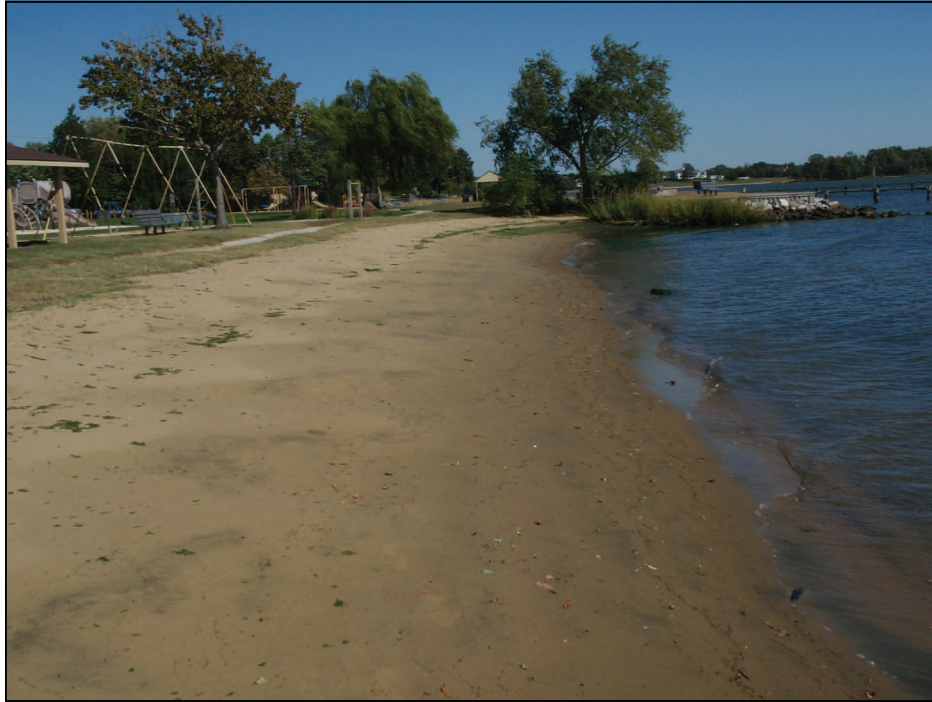
Figure 17. Gradually sloping natural beach area looking northeast toward bulkhead. This bulkhead inhibits longshore transport and results in shoreline accretion/up-drift deposition.
